Intelligent Dip Test Method for Performance Analysis of Polymeric Coating Material

Keywords: Aging, Dip test, Pollution

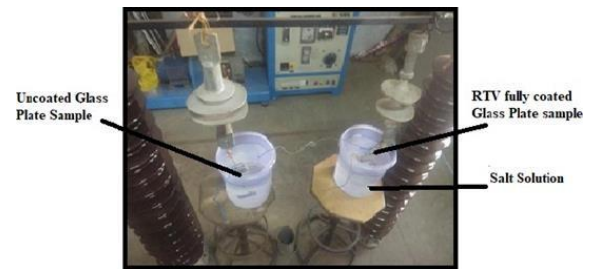
A modified version of Rotating Wheel Dip Test has been used in this research work for the evaluation of RTV coated glass plate insulator [5]. In this test method samples are dipped for 40 sec and taken out for drip period of 40 sec. This is followed by voltage application of 40sec and cooling period of 40sec.

Fig 1.3 Experimental setup for Dip test

The experimental setup of Dip test (modified Rotating Wheel Dip Test) is as shown in figure 1.3 Five glass plate samples i.e. Uncoated, RTV fully coated, 3/4th RTV coated, 1/2 length RTV coated and 1/4th length RTV coated are considered for the test. A combination of two samples were subjected to testing. The test procedure is described in the following steps.

Step:1 Dip Period: Each combination of samples was initially dipped in salt solution in the test tank consisting of NaCl and water mixed at a salinity of 5g/L for 40seconds (The dip period was as per the requirement of rotating wheel test- IEC standard 61109/62217).

Step 2: Drip Period: Samples were placed for a drip period of 40 seconds.

Step 3: Energized period: A voltage of 2.5 kV was applied for 40 seconds. Step 4: Cooling period: Samples were allowed to cool for the next 40 seconds after application of voltage.

The same procedure was repeated for the next 50 cycles. The voltage across resistors and leakage current was measured to evaluate the leakage current.

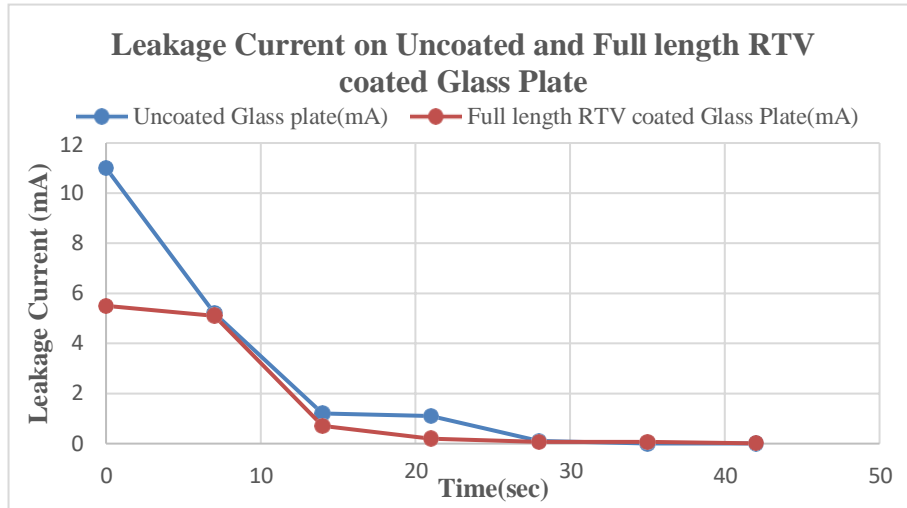
The same pattern of current was observed when Dip test is repeated on RTV fully coated and Uncoated Glass plate sample [8]. So, the leakage current values for different intervals of time are tabulated in Table 1.2 and Table 1.3 and shown in Figure 1.6 and Figure 1.7.

Fig. 1.6 Leakage current on Glass plate sample with RTV coating for full length and uncoated glass plate sample

Hence it is observed that RTV fully coated glass plate sample carries less leakage current compare to uncoated glass plate sample. The repeated test on uncoated and fully coated glass plate shows that initial current during the dip test is high then the current reduces over a period of time however the current on fully coated glass plate is

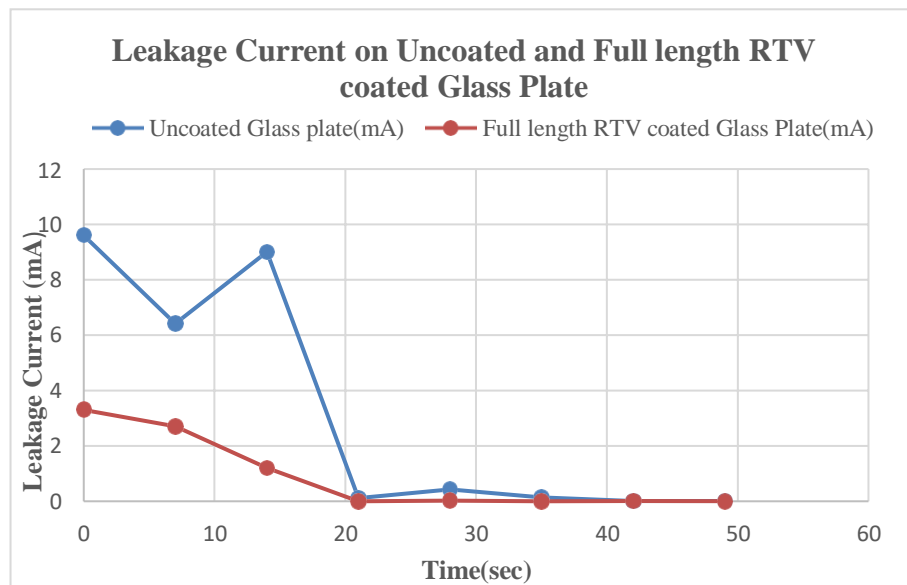
Fig 1.7 Leakage current on Glass plate sample with RTV coating for full length and uncoated glass plate sample

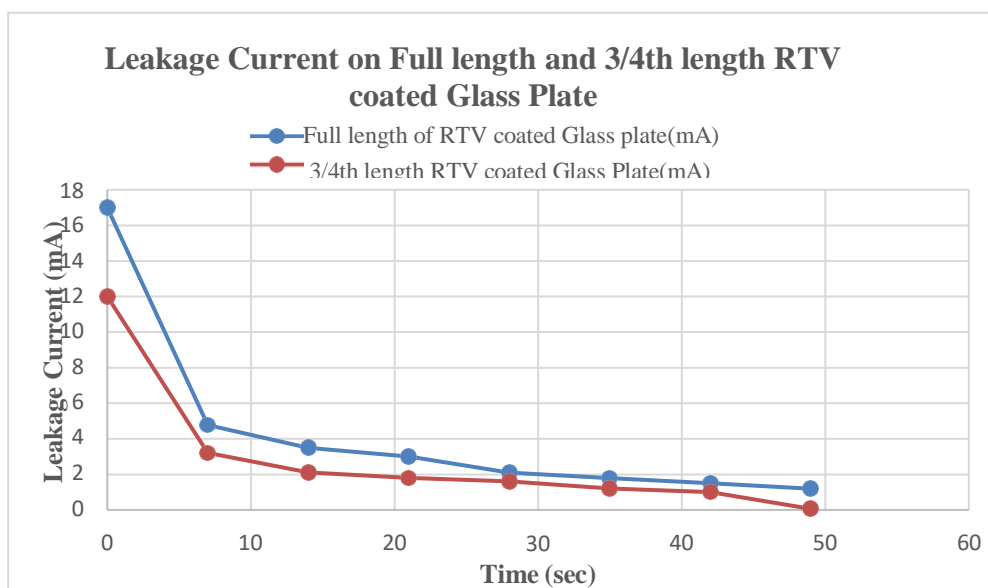
lesser than uncoated glass plate [9]. Further the test was also conducted on full length RTV coated and 3/4th length of RTV coated glass plate samples. Table 1.4 and figure 1.8 shows the leakage current measured for full length RTV coated and 3/4th length of RTV coated glass plate sample.

Fig 1.8 Leakage current on Glass plate sample with RTV coating for full length and 3/4th length coating

It can be seen that 3/4th RTV coated glass plate sample carries less leakage current compare to RTV fully coated glass plate sample. Further the test was conducted on full length RTV coated and 1/2 length RTV coated glass plate sample.

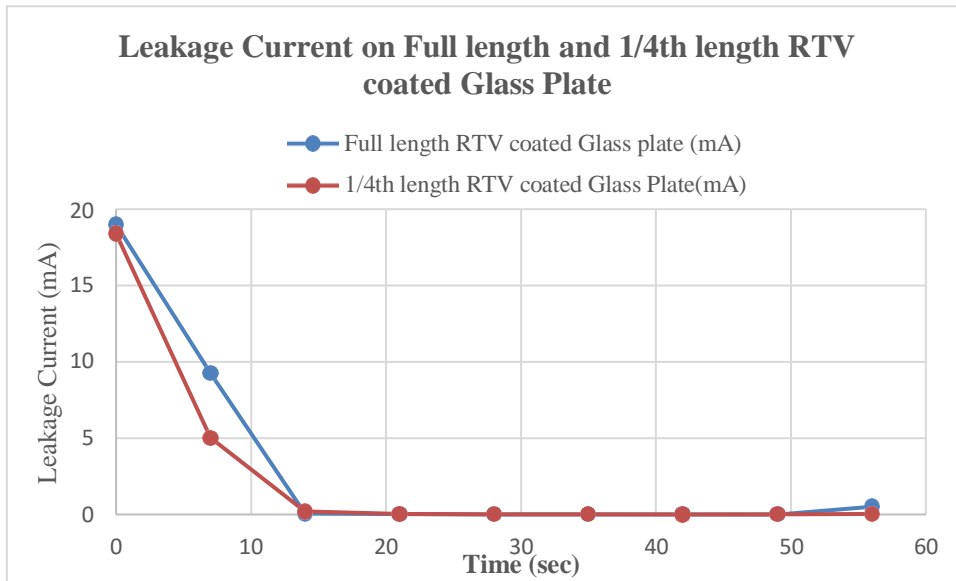
the leakage current measured for full length RTV coated and 1/4th length of RTV coated glass plate sample.

Fig 1.10 Leakage current from Dip test conducted on Glass plate sample with RTV coating for full length and 1/4th length coating

It is clearly observed that 1/4th RTV coated glass plate sample carries less leakage current compare to RTV fully coated glass plate sample [10].

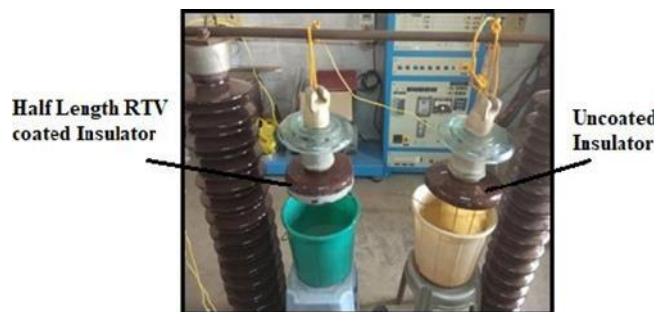
Dip test was conducted on two 11kv insulator with one insulator uncoated and another insulator is half coated as shown in fig1.11. When voltage is applied to these insulators at different intervals then leakage current was measured as shown in table 1.8 and figure 1.12.

Fig 1.11 Experimental setup for 11kV insulator

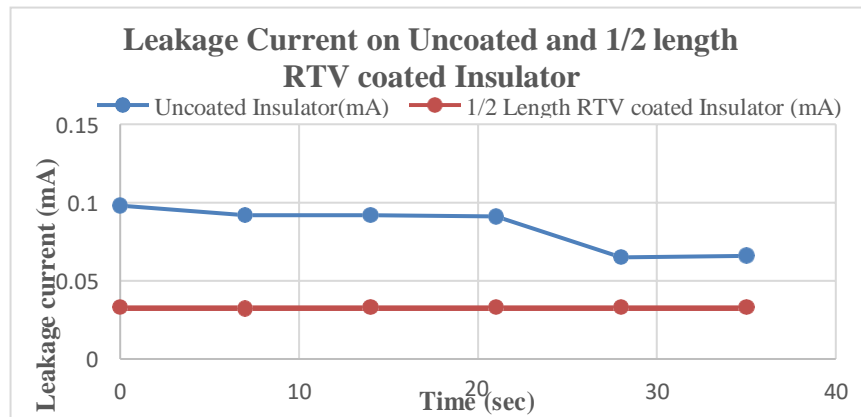
Fig 1.12 Leakage current on insulator with RTV coating for full length and uncoated insulator

The aging performance of RTV coated glass plate sample was good and remained hydrophobic after aging. Dip method of testing glass plate sample was easy and it can be preferred over rotating wheel tests. Dip test requires less investment than a rotating wheel test and less complexity. Dip test on porcelain insulators was also carried out for half coated and uncoated insulator. Half coated RTV insulator gives low surface current and shows better performance than uncoated insulator.
